Photographic Summary - Caveats

Door no. #2

Slide no. 4 of 13

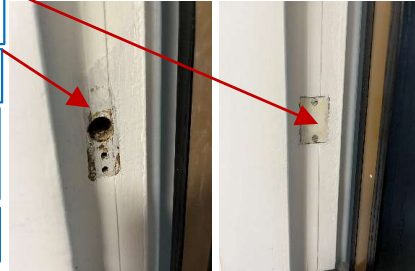
CAVEAT #1: Redundant contact plate interrupting intumescent strip in frame perimeter.

CAVEAT #2: Unpatched hole in one jamb of frame interrupting intumescent strip in frame perimeter.

CAVEAT #3: Bore hole drilled into underneath of frame to accommodate flush bolt – no plate and no intumescent protection in evidence.

CAVEAT #4: no intumescent protection in evidence behind socket.

REMEDY #1, #2 and #3 Competent person to effect ART to all holes eg. patch with solid oak hardwood. 3rd party approved flush bolt socket c/w intumescent gasket to be sourced and fitted for #3 and #4

REMEDY #1, #2, #3 and #4 Replace the 10mm x 4mm intumescent strip for the whole frame. BS 8214 section 13.2.3 recommends replacing seals which are compliant to BS476 pt 20/22 or BSEN 1634-1.

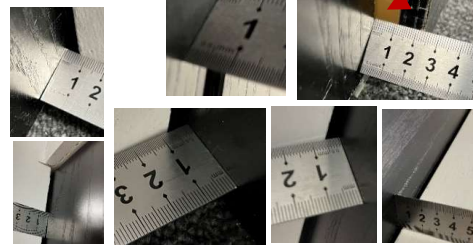
CAVEAT #5: LH main leaf (viewing from hinge/lobby side) is out of alignment with corresponding RH slave leaf by almost 24mm at the bottom edge – this will have a severe impact on its expected fire resistance. The main door appears to be hitting the maglock before it should be, contributing to this problem.

CAVEAT #6: The door assembly accommodates a split ceiling level and there is an overdoor to the office side. This seems to be an unrippled paint finished piece of doorblank with a routed groove and a fitted intumescent strip positioned off centre in its thickness.

CAVEAT #7: The majority of gaps between the door and the frame exceed 4mm with a measurement of 7mm recorded at the top and 6mm in the middle of meeting edges; a reading of 22mm at the bottom edge of the main leaf and 13mm at the bottom edge of the side leaf was also noted.

REMEDY #5 and #6 Competent person to effect ART and patch hinge recesses and make good. In view of excessive gaps, competent person to narrow frame opening with hardwood infill such that overall internal width is 9mm wider than the 2 no. doors. Fit hardwood lipping to base of overdoor and fit identical intumescent strip. As per BWF FDA recommendations for doors of this height, competent person to source and rehang doors using 4 no. hinges of grade 11 102mm x 76mm steel UKCA/CE marked in accordance with BS1935 and as Certifire CF certification.

REMEDY #7 In addition to **REMEDY #5 and #6**, because current FRA prepared by eg. Essex Fire Safety calls for fire and smoke doors (see page 30), BS 8214 section 13.2.3 recommends replacing seals which are compliant to BS476 pt 20/22 (fire) and 31.1 (smoke) or BSEN 1634-1 (fire) or 1634-3 (smoke) as a complete set. Seals should be as per the certificated test evidence for the door set and fitted by a competent person. Also fit a hardwood threshold to the floor and a drop threshold strip to the bottom edge of the door (accommodating flush bolt) eg. https://www.lorientuk.com/products/las8001-si_tom

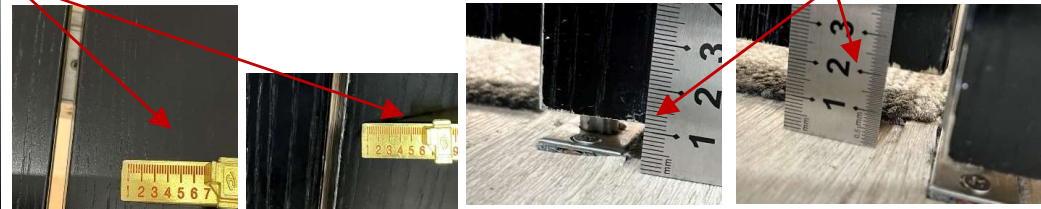
CAVEAT #9: No evidence of any intumescent protection behind edge fitted to 450mm (top) and 200mm (btm) flush bolts to slave leaf nor to sockets in head of door frame or floor. Unless proven to the contrary by a fire test evidence (not available), this is always recommended for fire resistant doors in accordance with section 11 of BS 8214: 2016.

CAVEAT #10: Bottom and middle hinges of main leaf badly fitted with screws missing and no intumescent protection behind blade.

REMEDY #9 Competent person to source and fit suitable intumescent protection for existing flush bolts 450mm (top) and 200mm (btm) and also for sockets with Certifire test evidence for use in a door assembly of this size and configuration ie. ULSADD+OD.

REMEDY #10
Taken care of by **REMEDY #5**
